Failure Analysis and Resin Evaluation of IUS SRM-1 92-inch Prototype Motor Case

Prepared by R. W. FILLERS, J. F. WARD, and P. K. GRANT
Materials Sciences Laboratory
The Aerospace Corporation
El Segundo, Calif. 90245

28 September 1979

Interim Report

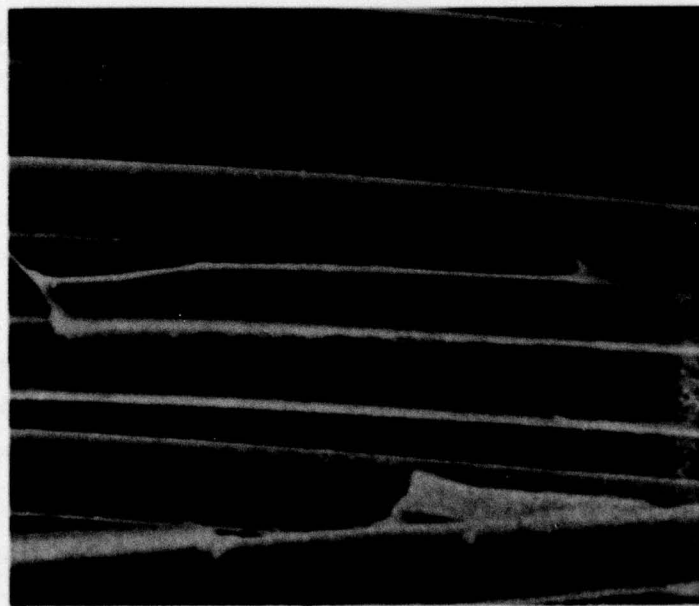
Fig. 1. SRM-1 Subscale 18-in. Vessel

Figures 1 and 2 show typical cross sections of the SRM-1 and SRM-2 subscale 18-in. vessels, which were wound as part of the case development program. (The SRM-1 vessel was fabricated using wet winding procedures, and the SRM-2 vessel was fabricated using a wet "pre-preg" version of the same system.) The clean separation between fiber and resin evidenced in both figures indicates poor wetting, or adhesion, between the Kevlar fibers and the epoxy resin. Small pieces of poorly bonded resin are present in both figures, but particularly in Fig. 2.

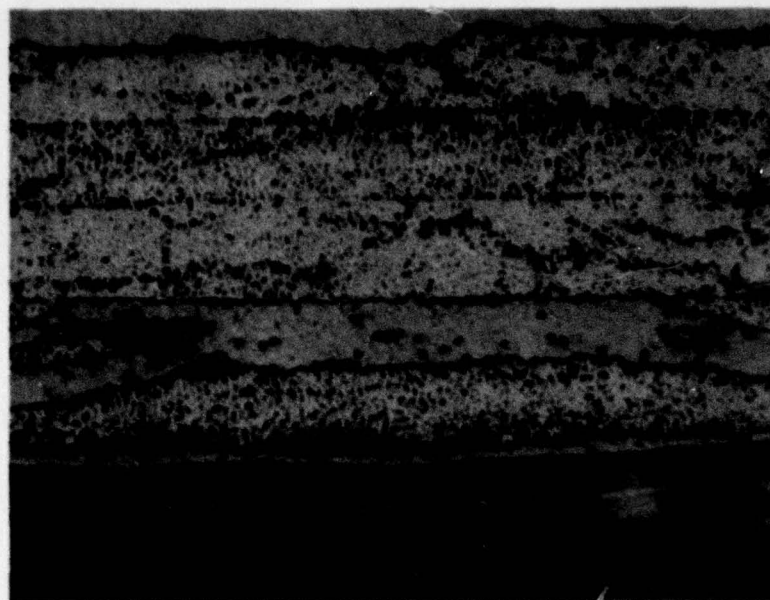
Fig. 3. SRM-2 Subscale Vessel: Polished Cross Sections

Figure 3 shows polished cross sections of the SRM-2 subscale vessel, taken at 50 \times (with the optical microscope). The two cracks running across the bottom of the pictures are delaminations, which occurred when the case burst. Note the poor distribution of fibers in the various wraps, or layers, and the resulting voids. The thickness of the inner wrap is approximately 0.010 in., whereas the outer wrap varies between 0.006 and 0.014 in. Also note that no fibers are split along the length of the crack.

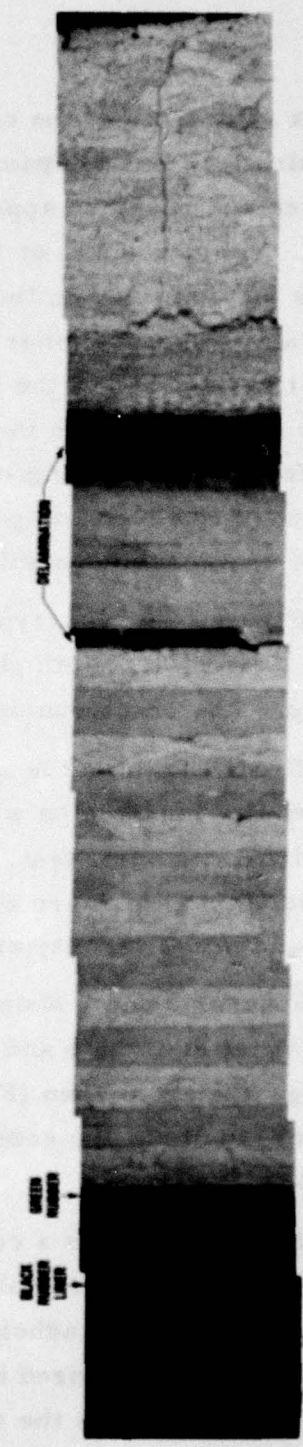
Fig. 5. Cross Section of Prototype at Station 1

Figure 5 shows a cross section of the case at Station 1. The region marked green rubber shows the material used to patch the liner (black rubber) prior to winding the case. This patching was used to fill the low spots and recover the contours of the discrepant plaster mandrel and rubber liner. Figure 5 also shows many radial cracks in the hoop wraps, which were observed prior to pressure testing. (These cracks were also noted

in the x rays taken of the case prior to hydrostatic testing.) They are approximately evenly spaced every 0.04 in. in all the outer hoop wraps observed and result in approximately one percent strain relief in the hoop wraps. The cracking, or "crazing," probably resulted from the thermal strains incurred during the cure cycle and indicates how highly strained the case was. Since the inner portions are held together by the outer, cracking is most pronounced at the boundaries or free surfaces. Note that cracking is also evidenced at the inner boundary adjacent to the rubber liner. Therefore, local crazing may not be prevented simply by greater interspersation of the hoop and polar layers. Finally, Fig. 5 shows the nonuniformity and nonhomogeneity in wrapping, with considerable void space.

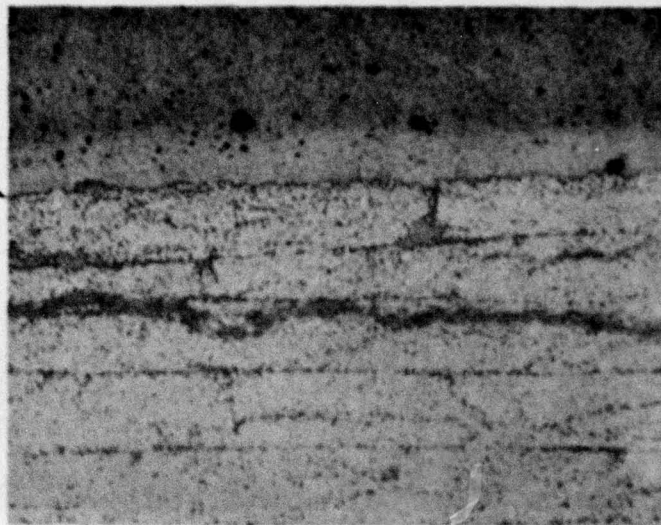
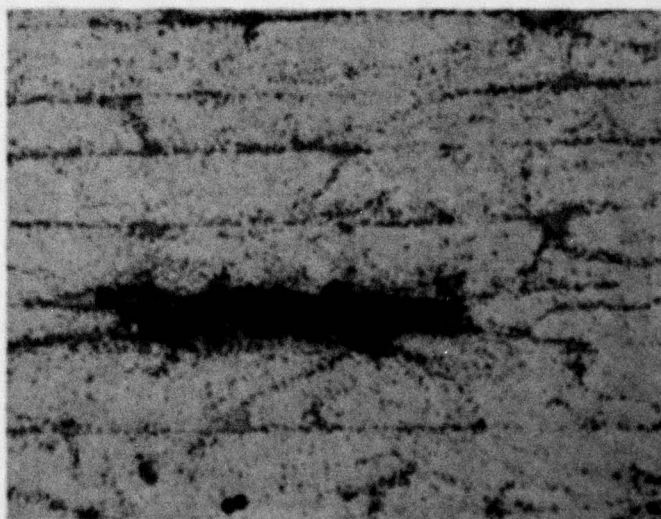
Fig. 6. Cross Section of Prototype at
Station 2

Figure 6 shows a typical cross section of the dome of the motor case region (Station 2). Both photographs exhibit porosity and nonuniformity in winding. The crack running across Fig. 6a occurred during burst testing.

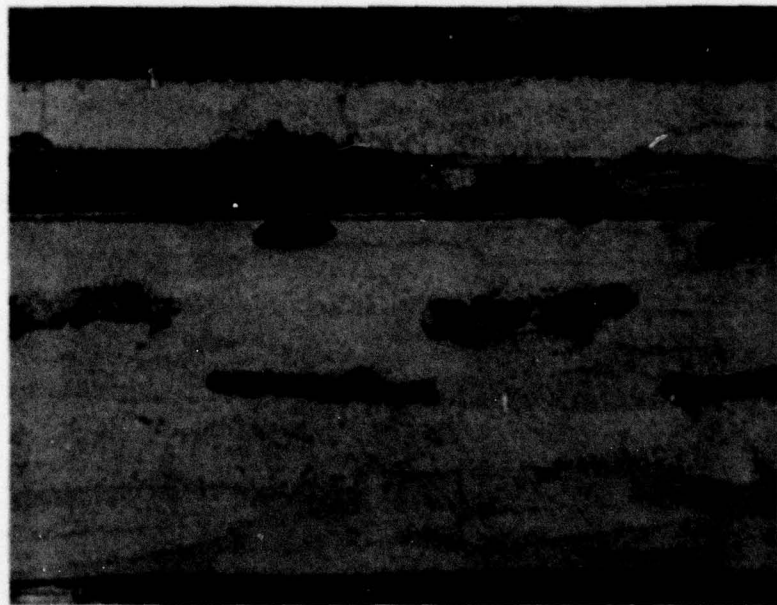
Fig. 7. Cross Section of Prototype at
Station 3

Figure 7 shows the appearance of the motor case in the skirt overhang (Station 3). This region was chosen because it appeared to be unaffected by the hydrostatic burst test. The radial cracks spaced 0.04 in. apart that were noted in Fig. 5 are also evidenced here (Fig. 7a). Considerable void space and nonuniformity are evidenced in the mid-thickness region (Fig. 7b).

Although additional measurements indicate that the aged resin system attains its proper strength if it is later properly cured, it is feared that the gelled resin in the inner regions of the case may fracture due to its brittle, weak state as the stresses from the winding of the outer portion of the case are imparted to it. In any event, premature gelling leads to a nonuniform distribution of strain in the finished case and is probably partly responsible for the radial cracking evidenced in Fig. 7.

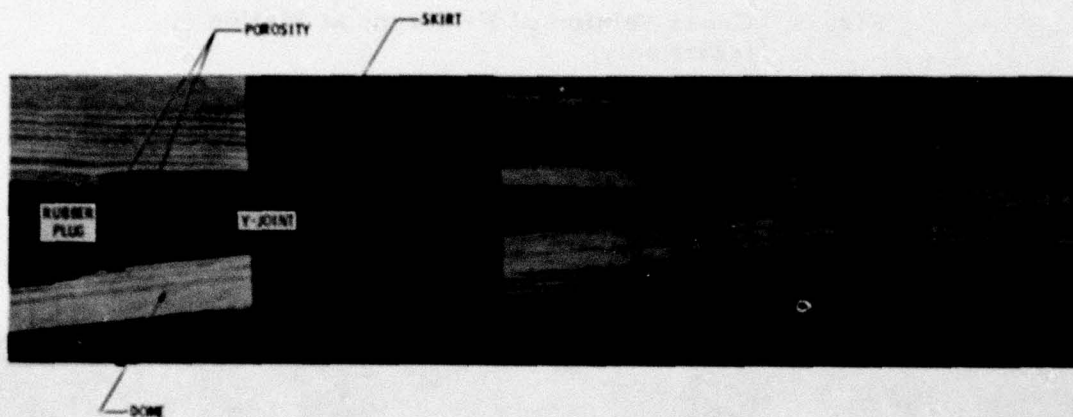
Fig. 10. Cross Section of Prototype Y Joint
(30 deg Aft)

Figure 10 shows a cross section of the Y joint taken at 30 deg aft. A high degree of nonuniformity is evidenced, especially in the layer adjacent to the rubber and the adhesive film laminate. Hoop wrapped filler is seen over the rubber plug used to correct large contour mismatch. Additionally, as noted previously in the other regions of the case, extensive voids were observed in both composite and adhesive.

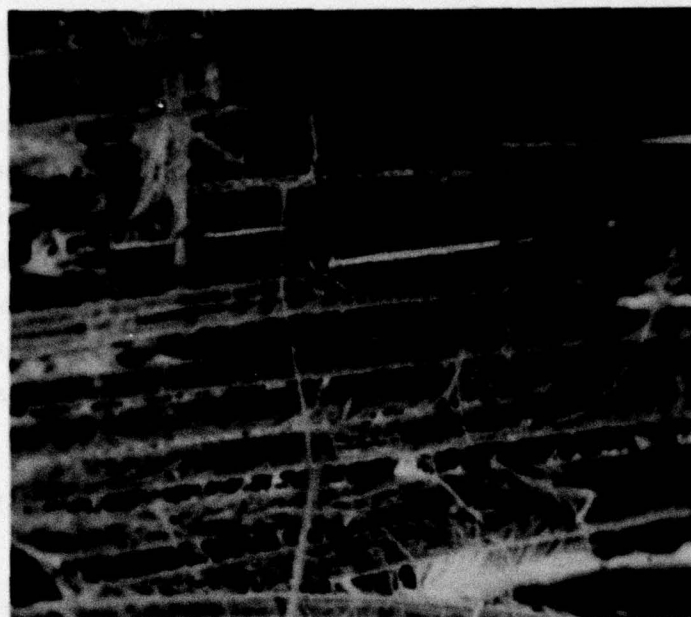
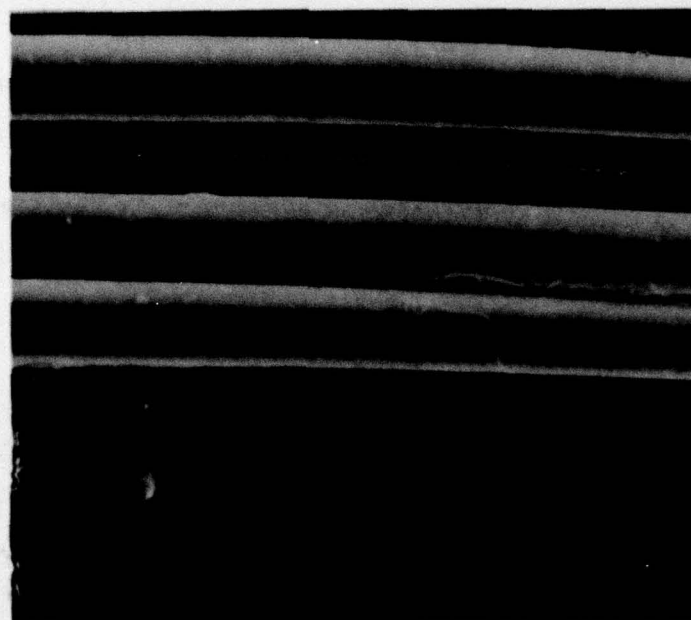
Fig. 11. Evidence of Fiber Wetting

In addition to the optical microscopy of the polished specimens reported above, specimens were removed from the case dome at Stations 2, 3, and 4 and examined under the SEM. The only evidence of fiber wetting was observed in the skirt region in (Fig. 11a). This good adhesion was quite local and was not evidenced in any other region of that particular specimen nor in any other portion of the case. In general, all regions of the motor case observed with the SEM were identical to that shown in Fig. 11b.

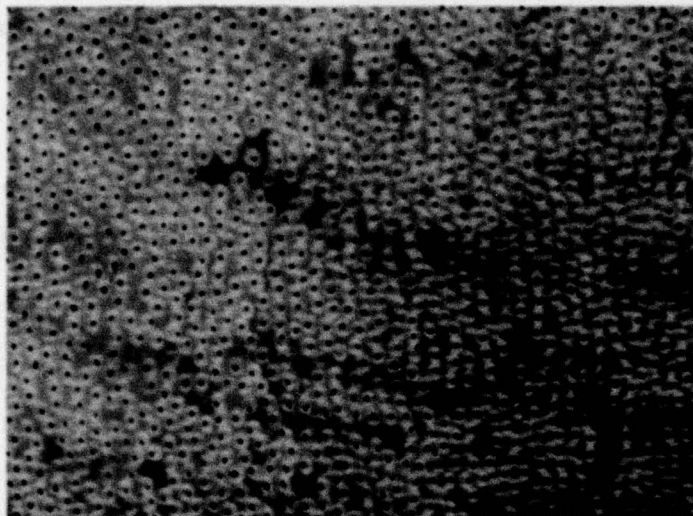
Fig. 12. Fiber Count on Polished Cross Sections

The second approach for determining resin content consisted of carrying out an actual fiber count on polished cross sections taken from the skirt and dome regions of the SRM-1 prototype case (Fig. 12). To obtain a statistically meaningful approximation of the resin fraction, a relatively large (0.015×0.020 in.) cross section was measured in a randomly chosen area of the case. A total of 1097 of the 0.00047-in. -diameter fibers were counted in the skirt region and 1073 fibers were counted in the dome region; the dots evidenced near the center of each fiber indicates that it was included in the count. From these counts, the volume and weight fractions of the resin were calculated and are reported (Table 1).

A careful examination of Fig. 12b indicates that approximately 40 to 50 fibers could be placed in the void regions. This is equivalent to between

2 and 3 percent void space, which when substituted into Eq. (2) yields a good correlation between the two techniques. Due to the inhomogeneity of the composite, the actual fiber count technique yields the best results, and the areas used here should be considered minimal. Future studies should include counts from many areas of the case.
